# Surmac Saves Owner \$5 Million with Project-Rescuing Concrete Restoration

## THE BROADWAY LOFTS PARKING GARAGE STORY

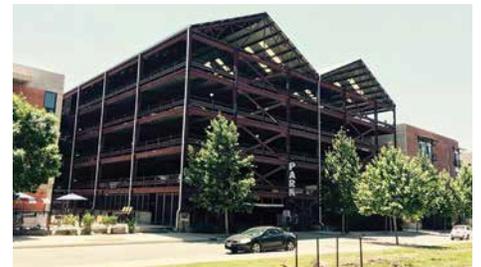
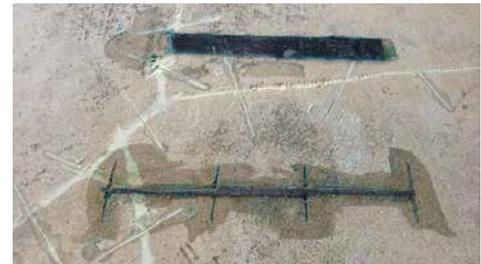
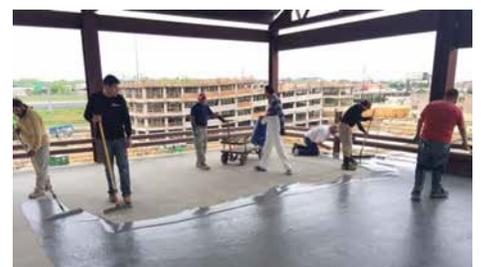
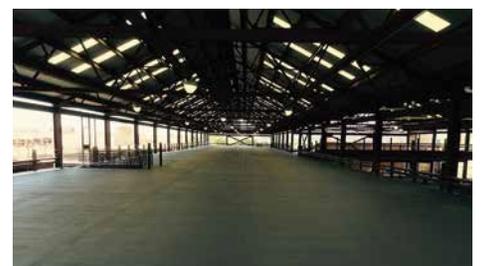
"It's a pan and beam garage supporting a 308-unit residential project," Watson explains. "Almost immediately after the concrete deck was placed in 2012, cracks started to appear on all five levels. Forensic engineers determined the aggregate was too small, it had been way over-watered, and no steel was used in the concrete. The pH was 6.8, meaning near neutral, threatening the galvanized pans. A \$5 million investment was falling apart before the owner's eyes.

1. Shot blast and diamond grinding removed the top quarter-inch of carbonated concrete.
2. Low-viscosity, hybrid polyurethane-polyurea mender was applied to all cracks.
3. Carbon fiber strapping and staples were carefully implanted over the main girder beams to increase rigidity and mitigate flexing.
4. Miracote MiraPrime Aqua-Blok served as a deep-penetrating alkali-reactive internal hardener. The chemical reaction creates far denser concrete and lifts pH (to nearly 12 in this case).
5. Miracote MPC Park Deck System (including MPC hard) in combination with MiraGard Dry Look Sealer was applied to strengthen wear surface durability.
